## Sea Water Injection - Case Study

#### 4 x Azcue Long Coupled End Suction Self-Priming Centrifugal Pumps

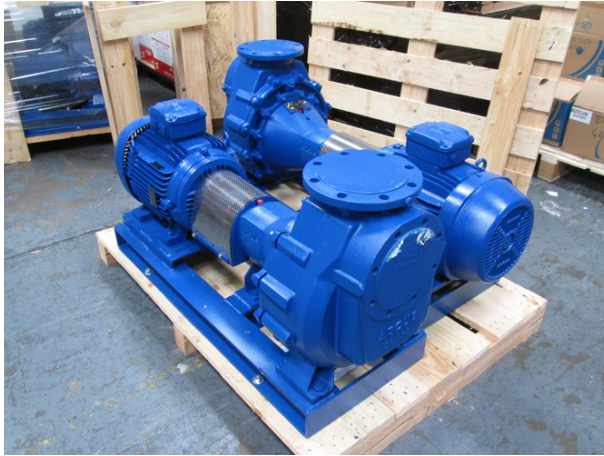
Model	CA 150-25
Fluid	1.1 kW 6 Pole 400/2/50 IP55 TEFC
Casing	Stainless Steel
Impeller	Stainless Steel
Shaft	Stainless Steel
Flow Rate	200m <sup>3</sup> /hr at 14m head
Suction Discharge Ø	150/150
+	1450RPM
	18.5Kw
	380V/3Ph/50Hz

- ✓ We selected 4 of our CA 150-25 long coupled end suction self-priming centrifugal pumps in stainless steel 316. The long coupled design separates the pump from the motor allowing easier maintenance and also reducing the risk of any fluid entering the motor in the event of a mechanical seal failure. The pumps are fitted with 4 pole motors running at 1450RPM, the slower motor speed reduces the wear on the pump in the long term, making them perfect for 24/7 applications such as this. We also supplied a 2 year recommended spare parts package to further avoid any potential issues for the customer.
